Restoration of a degraded torrential stream by means of a flood control system: the case of Arroyo del Partido stream (Spain)

J. A. Mintegui Aguirre, J. C. Robredo Sánchez,
C. De Gonzalo Aranoa & P. Huelin Rueda
*Escuela Técnica Superior de Ingenieros de Montes,
Universidad Politécnica de Madrid, Spain*

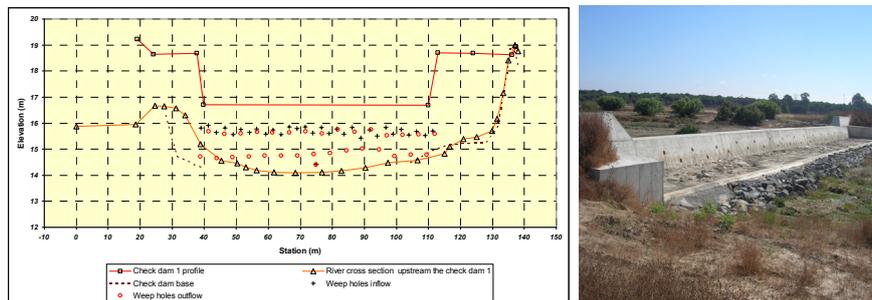
The CD1 height is 2.6 m above the current streambed. Originally the frontal spillway was 2.0 m high, 70.0 m long, and 2.0 m width, situated at an average altitude of 16.7 m. Thirty one weep holes, with 0.3 m in diameter, crossed the structure from the upstream to the downstream side, draining the water volume stored behind the structure. The weep holes were arranged in two rows (of 15 weep holes each) and a single bottom drain (Figure 2). The lateral spillway was placed immediately upstream of the structure along the left riverbank and coated with a rocky breakwater and a cyclopean concrete lining in order to prevent erosion when the diverged discharge flows into the flood-lamination-sedimentation area. The lateral spillway has a length of 140 m and its altitude ranges between 16.70 and 16.77 m.

Figure 2: CD1 elevation view (left) in 2006 and photograph (right) in July 2007.

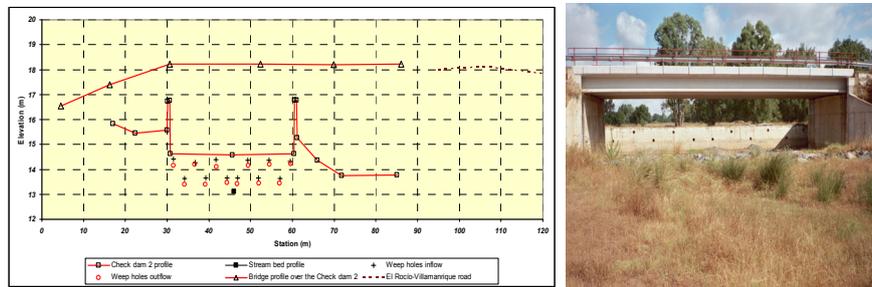
The CD2 is 1.5 m high and was built immediately upstream of the bridge over the Cañada del Pinar stream, on the road connecting El Rocío and Villamanrique (Figure 3). Its spillway is 29.5 m long, 2.0 m high and 3.0 m width, with an average altitude of 14.62 m. The structure is crossed by 12 weep holes, 0.3 m in diameter, draining the volume stored behind the check dam, arranged in two rows (of 6 weep holes each).

Figure 3: CD2 elevation view (left) in 2006 and photograph (right) in July 2007.

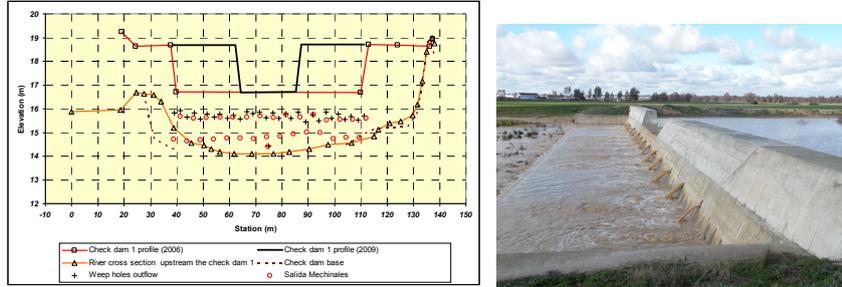
The results of the first flood were surprising. The pressure of the flow dragged the gravel blocking the weep holes through them, becoming those lasts operative again, as shown in the photograph in figure 5. The estimated flow distribution at the CD1 in these events, is shown in the Table 2.

The photograph in figure 5 shows the situation of the CD1 at 13:00 h (local time) on February 2nd 2009, during the flood that started the previous day. At that time, the estimated hydrograph (figure 6) points out a flow rate of $15 \text{ m}^3 \cdot \text{s}^{-1}$. This value matches with the stage-discharge curve at the CD1 at the same time, as shown in the photograph in figure 5, where all the weep holes were draining at their maximum capacity and there is no discharge over the frontal spillway threshold.

Figure 5: Left: CD1 elevation view with the final frontal spillway design. Right: Photograph of the CD1 at 13:00h on February 2, 2009, after the flood of the previous evening (image courtesy of C. Urdiales, DNP).

The adjustments of the CD1 were carried out after the summer of 2008, and were operational at the beginning of 2009. Their aim was the reduction of the flow crossing the CD1 to The Arroyo del Partido channel through its front face. With that purpose the following measures were implemented: a) to modify the initial frontal spillway section (2006), decreasing its draining surface, b) to cover the weep holes with gravel, delaying the discharge through them during floods.

Accounting these modifications, the new frontal overflow section became trapezoidal, 20 m long at the base and 24 m long at the crest, maintaining a height of 2 m (Figure 5). The new stage-discharge curves of the Flood Control System at the CD1, after the modifications are shown in Figure 4, right chart.

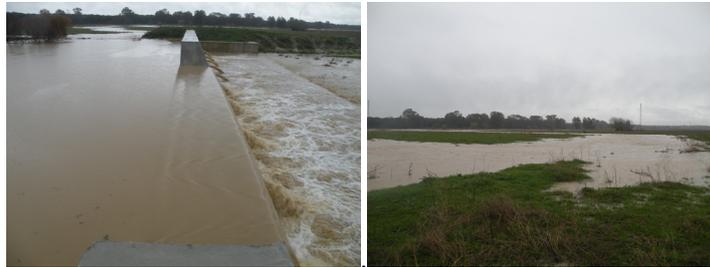
Figure 7: Flood in the Arroyo del Partido stream at 13:10 h local time on February 5 2009. Left: flow distribution at the CD1. Right: the flood flows downstream over the flood-lamination-sedimentation plain.

The left photograph in Figure 7 shows the flood on February 5th 2009 at the CD1, at 13:10h (local time). As the hydrograph shows (Fig. 6), the stream flow at that moment was about $65 \text{ m}^3 \cdot \text{s}^{-1}$, where $20 \text{ m}^3 \cdot \text{s}^{-1}$ crossed the check dam front face ($15 \text{ m}^3 \cdot \text{s}^{-1}$ through the weep holes and $5 \text{ m}^3 \cdot \text{s}^{-1}$ over the spillway threshold). The remaining flow, $45 \text{ m}^3 \cdot \text{s}^{-1}$, were diverged to the flood-lamination-sedimentation area over the lateral spillway, as shown in the same photograph, and ran downstream over the floodplain, as shown in the right photograph in Figure 7.
